Re: Well Closure Report
Abandoned Water supply Well No. 5 (AW-5) at
Marine Corps Air Station, El Toro, California
SWDIV Contract Number: N68711-93-D-1459
DCN SW 9166, Delivery Order Number: 0070

This Well Closure Report describes the well inspection activities conducted to confirm destruction of the former water supply well AW-5, located at Marine Corps Air Station (MCAS) El Toro (herein after the Station). OHM Remediation Services (OHM) conducted this work on behalf of the Navy under the Southwest Division Naval Facilities Engineering Command (SWDIV) Contract No. N68711-93-D-1459, Delivery Order (DO) 0070.

FACILITY LOCATION MAP
ABANDONED WATER WELL AW-5

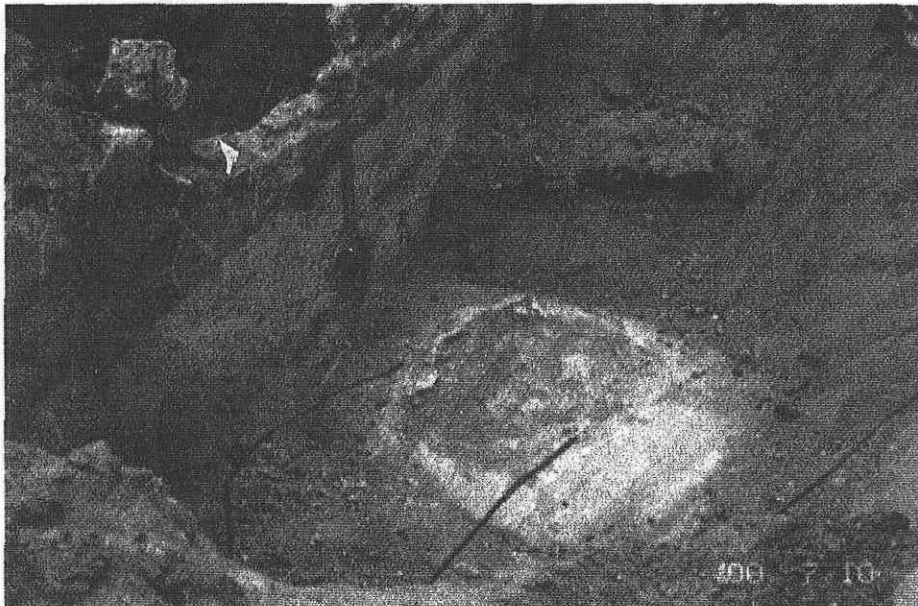
During inspection of the AW-5 well location, a circular mushroom shaped concrete cap was observed, consistent with the top concrete plug that would have been installed during the destruction of a well following California Well Standards. The well cap was approximately seven feet below ground surface in a concrete vault. Following inspection, the excavation was backfilled.

Base of well vault, view of cement-filled previously destroyed well, AW-5.

OHM recommends that this information be submitted as evidence that water supply well designated as AW-5 appears to have been previously destroyed following California Well Standards, and *no further action* is needed at this site.

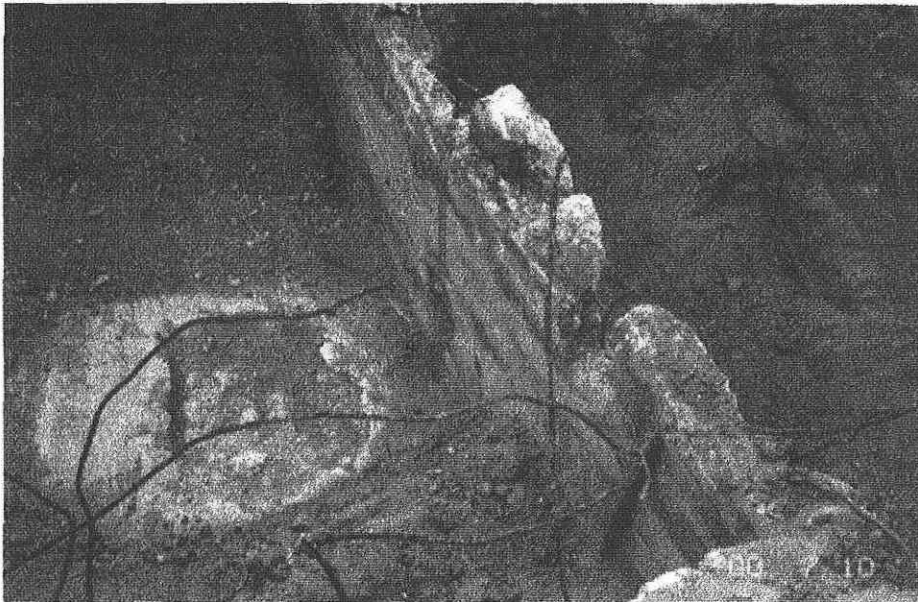
View of vault wall and re-bar.
